INSPECTION CONDITIONS

CLIENT NAME:	Darcy & Alan O'Brien.
MAILING ADDRESS:	Home Sweet Home
CLIENT CITY/STATE/ZIP:	Medford, OR.
CLIENT PHONE #:	541-555-1212
CLIENT FAX #:	
INSPECTION SITE:	Same.

Cornerstone Inspections, LLC
PO Box 5506 Central Point, OR 97502
541-664-1947 541-664-1937(fax)
CCB# 123990 cornerstoneinspections.us OCHI# 888

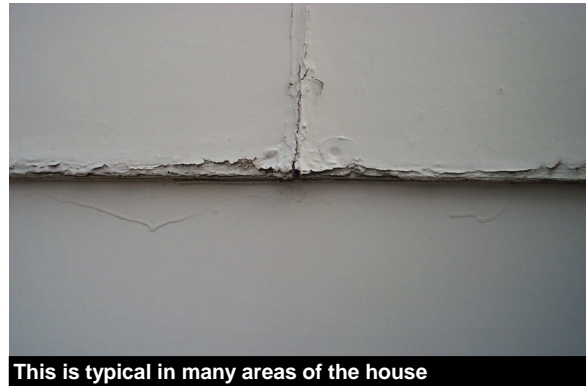
This is typical in many areas of the house

Showing signs of deterioration from moisture. Areas that have this condition should be monitored for increased deterioration. Keeping full paint coverage over these areas will greatly slow the breakdown of this material.

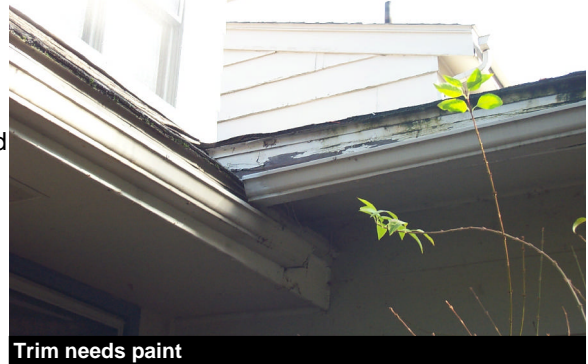
Paint/finish needed. Trim at rear left of house is too close to the roofing material and is showing signs of decay. I recommend cutting away from roofing and refinishing.

Trim needs paint

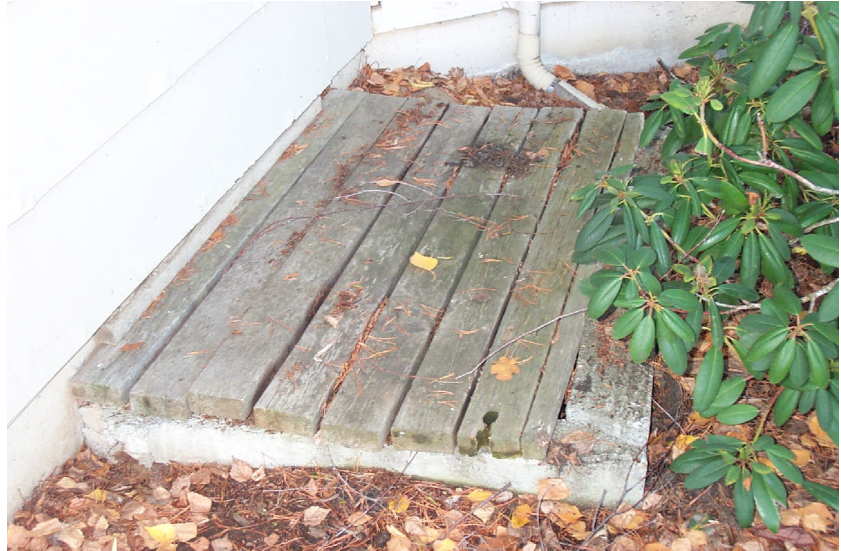
Crawl space is accessible through 3 external and 1 internal access points. One access cover(see picture) is falling part and will need to be replace in the future.

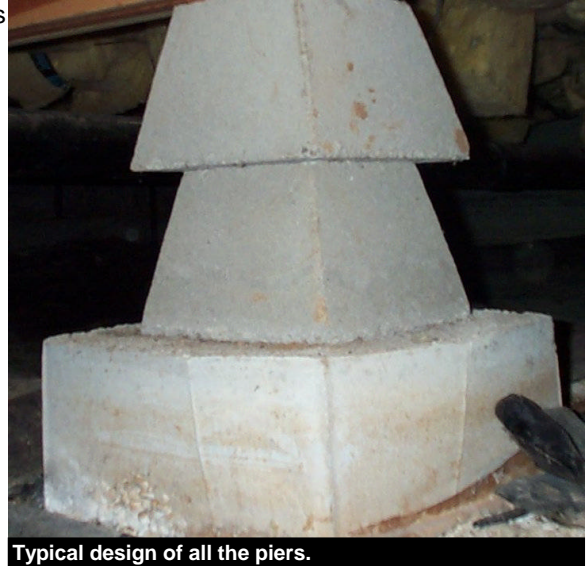
The design of the piers is non standard. However they seem to be functioning as intended. If you are concerned about the design's stability I recommend further evaluation by a structural engineer.

Typical design of all the piers.

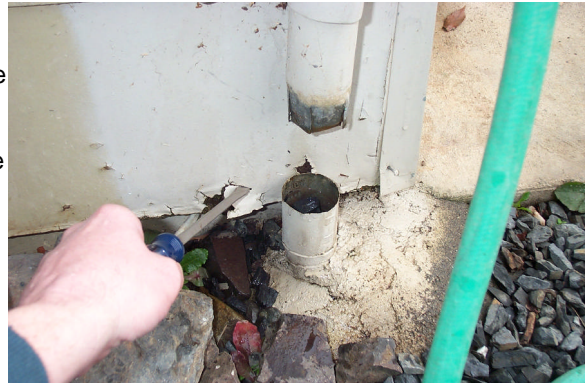
Some of the downspouts need service. The one to the left of the garage is missing a section. Water is damaging the siding. The one to the right of the garage needs to be routed away from the foundation. There is one missing completely at the rear left of the house. I

recommend a gutter professional or handyman be consulted to repair the downspouts.

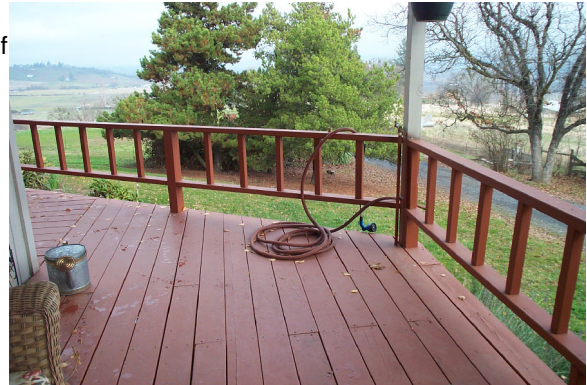
The deck is in new condition at the front of the house and in serviceable condition at side of the house. The deck does not meet current requirements that state there should be no openings in the railing of greater than 4". THIS IS CONSIDERED A SAFETY HAZARD and should be remedied by a qualified carpenter.

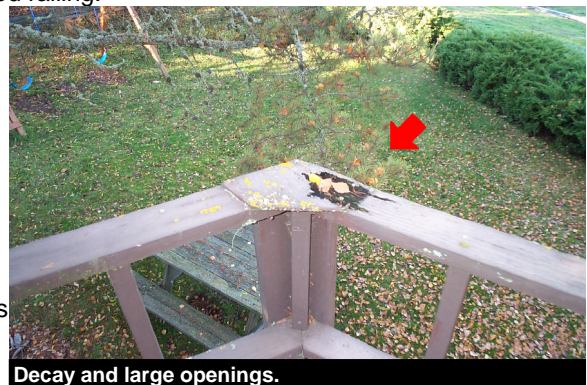
Metal flooring with wood railing. The metal flooring is good. The railing has larger than 4" openings. THIS IS CONSIDERED A SAFETY HAZARD and should be corrected by a qualified carpenter. Also, a section of the railing is showing signs of decay.

Decay and large openings.

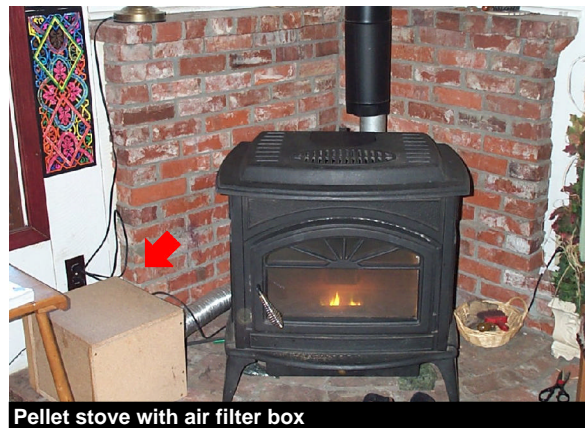
Pellet stove located in front of house at right.

The pellet stove has been modified from its original design but seems to be functioning properly. See notes in heating system condition. The hearth is cracked at the front edge.

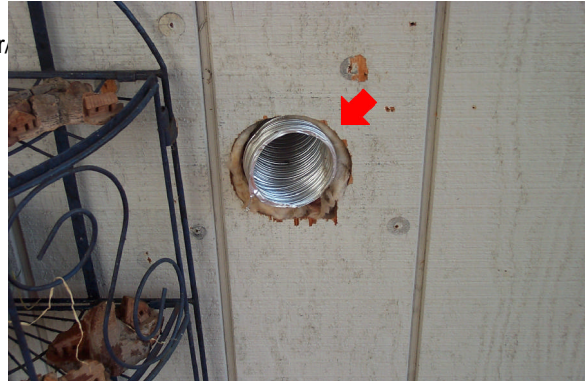
The combustion air vent is missing a cover screen.

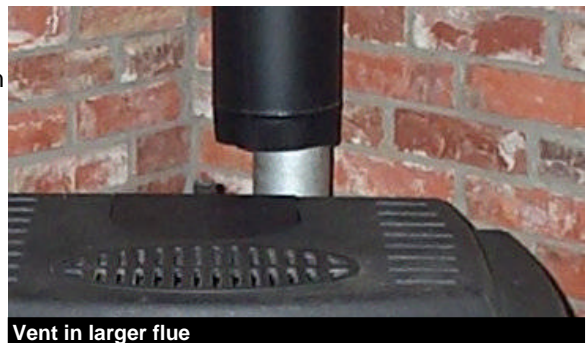
Exhaust venting is run up through a larger wood stove vent which prohibits close inspection. The venting system seems to be functioning good.

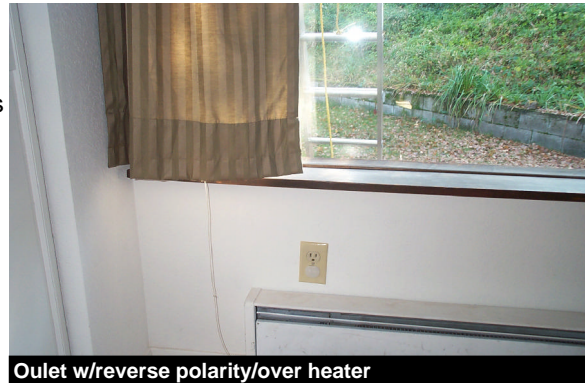
There are some needed repairs to the outlets in the home. Reverse polarity exists in the master bedroom, the room at the top of the stairs, and in the upstairs room at the rear left. THESE ARE ALL SAFETY HAZARDS. I recommend correction by a professional electrician.

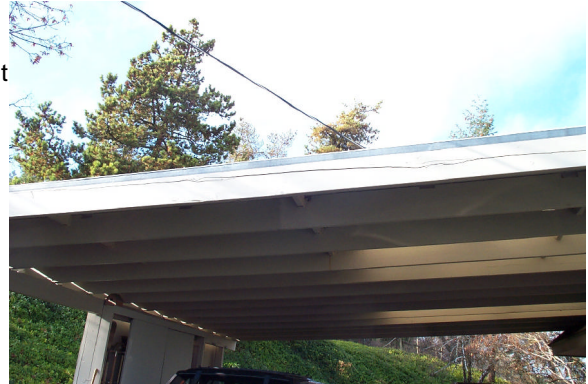
Cracked 2X12 joist in front of carport . I recommend repairing it or monitoring it for signs of failure.

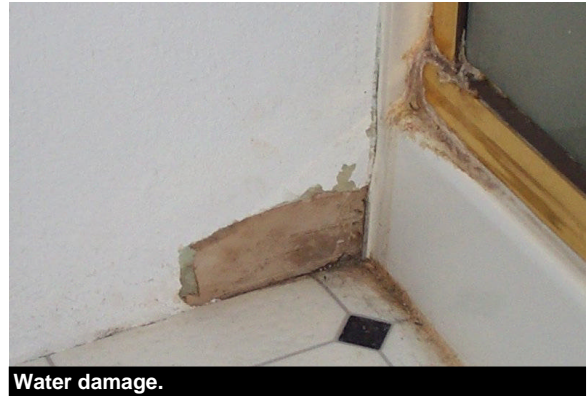
Tub stopper not installed.
 Wall to left of shower
 damaged by water.
 Floor appears to be
 okay. Source of water
 appears to be gone.
 Recommend repair
 and monitor.

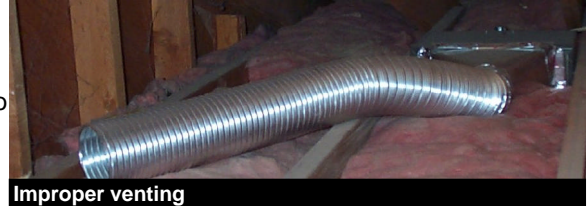
Appears serviceable
 Tub and shower areas appear serviceable
 Not properly vented to
 outside of house.
 Recommend vent be
 attached and vented to
 exterior of house.
